Airframe Structural Fatigue

Past, Present and Future

James Burd

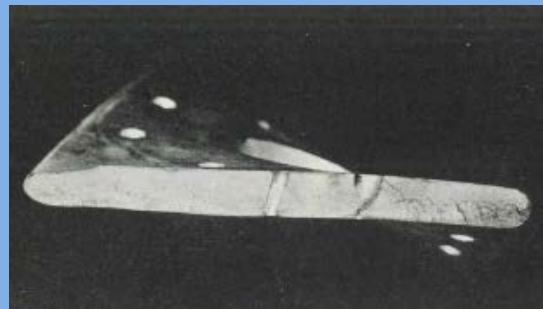
Fatigue Crack in
Propeller Blade

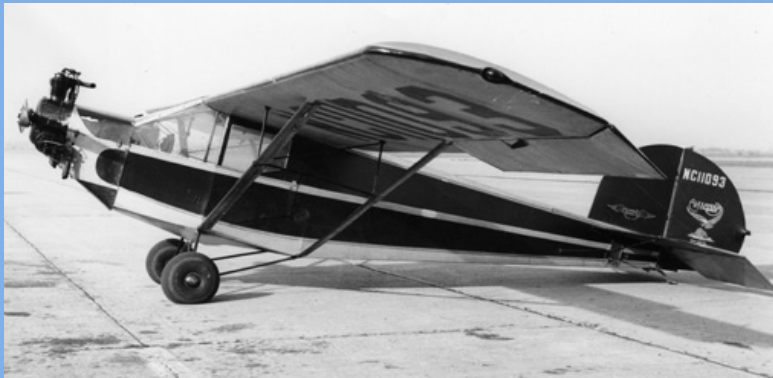
- The earliest documented fatigue failure on a general aviation aircraft operating in the USA occurred on 2 May 1925 when an Alexander Model D-2 crashed due to a wing strut fatigue failure which was investigated by the then Bureau of Standards.

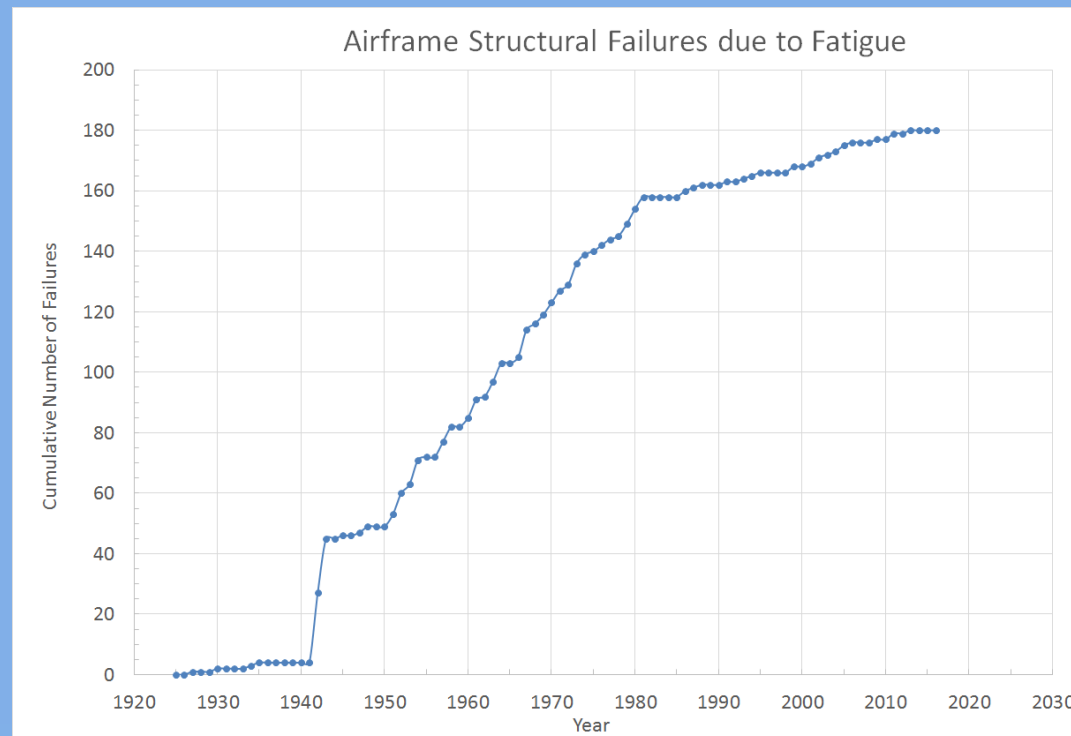
- Historical trends show a rapid rise in fatal crashes due to fatigue post WW2 and then a distinct drop in crashes due to fatigue after around 1980 (industry actively addressing the issues)

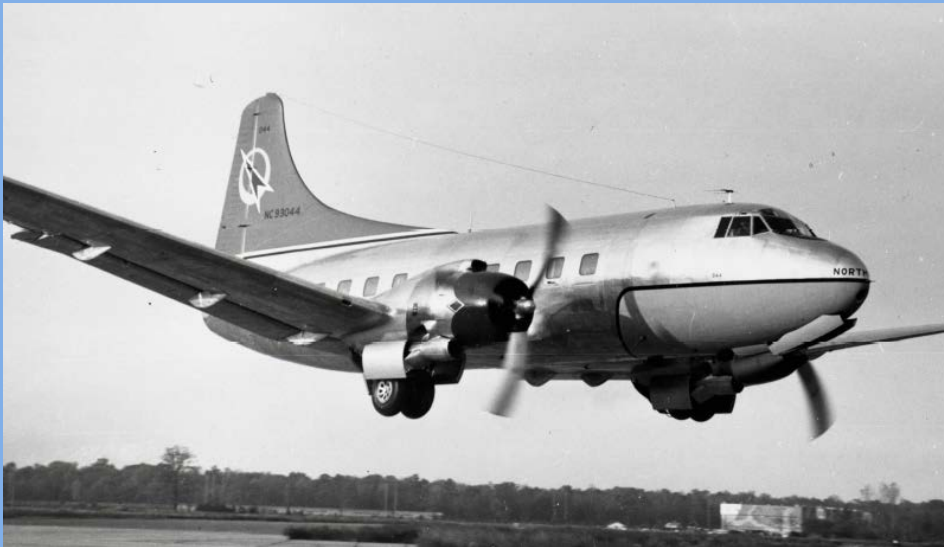
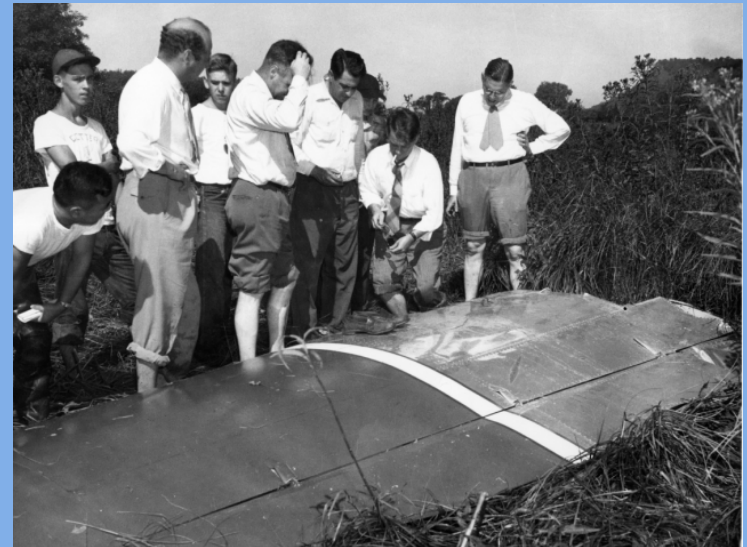
Northwest Airlines Flight 421 Chicago to Minneapolis-
Martin 202, NC93044 – 29 Aug 1948

During flight through a thunderstorm area, a structural failure originating in the wing panel attachment fitting occurred. The aircraft then broke apart in the air resulting in fatal injury to all on board.

- Investigation discovered high stress concentrations caused fatigue failure
- Full scale fatigue testing was conducted by Martin. Did not find any cracking during visual inspections. Following the accident, a more detailed inspection found fatigue cracks at the joint.
- CAA mandated inspections & mod.
- CAA published as example in TM 103
- Accident was impetus for CAR 4b.270 *new fatigue rule

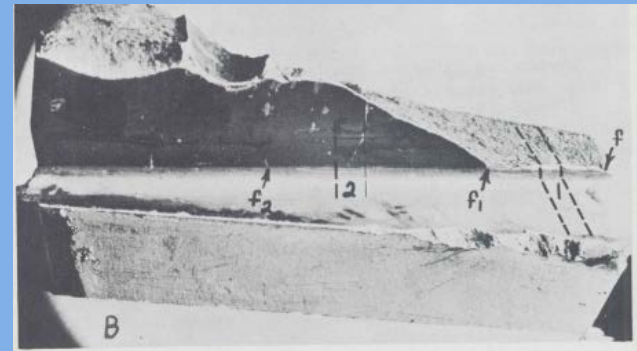
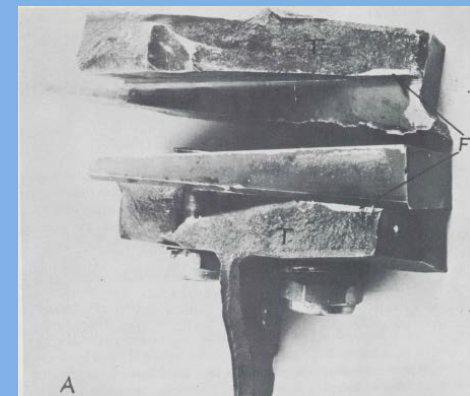
Wing Joint at WS187 Failure – Spar Cap and Fitting are 75ST Material

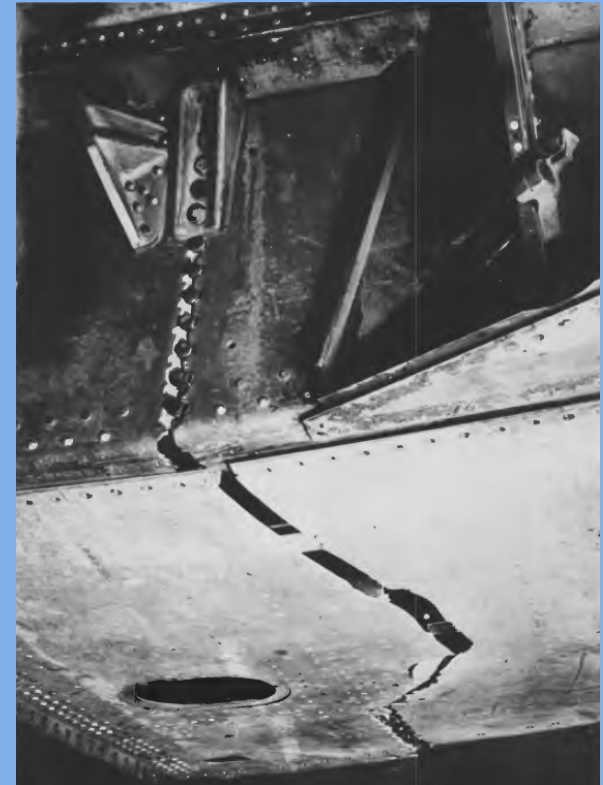
ARL Tests: 1950-1964:

Over 100 P-51 wings
fatigue tested
Multiple Failures in Wing
Material = 24ST
WS 17.5 to 28

Wing Spar Fatigue Failure at
Attachment WS 17.5 (same as
in-service failure location)

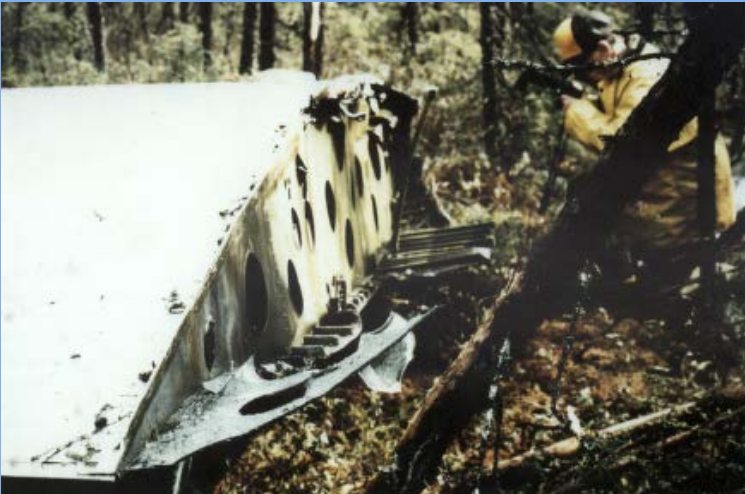
The left wing failed, under normal flight loads, as a result of a fatigue crack in the centre section lower wing skin. Anomalies in the radiographs taken during mandatory non-destructive testing inspections were not correctly interpreted.

- Two key issues identified at that time by the accident investigation:
 - *“A 15-inch fatigue crack was visible in radiographs taken at the normal inspection cycle, 297.8 hours of flight time before the accident, but was not interpreted by the radiographer”*
 - *“There are no aviation regulatory standards applicable to radiographic work performed on aircraft”*
- Transport Canada issued an emergency AD to audit all radiographics for this inspection and a mandatory modification.

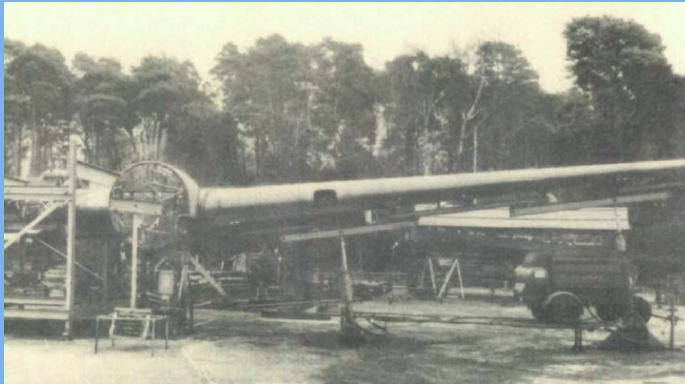
- RAE Full Scale Fatigue Tests in 1960
- Results indicated multiple fatigue crack sites near wing joint

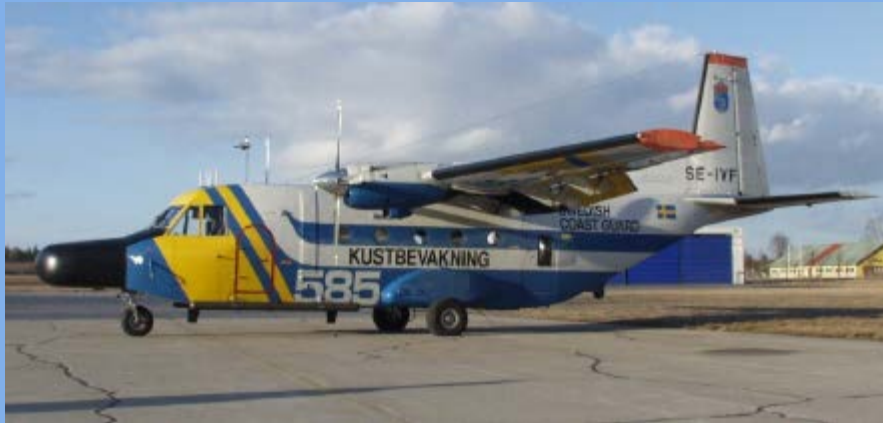
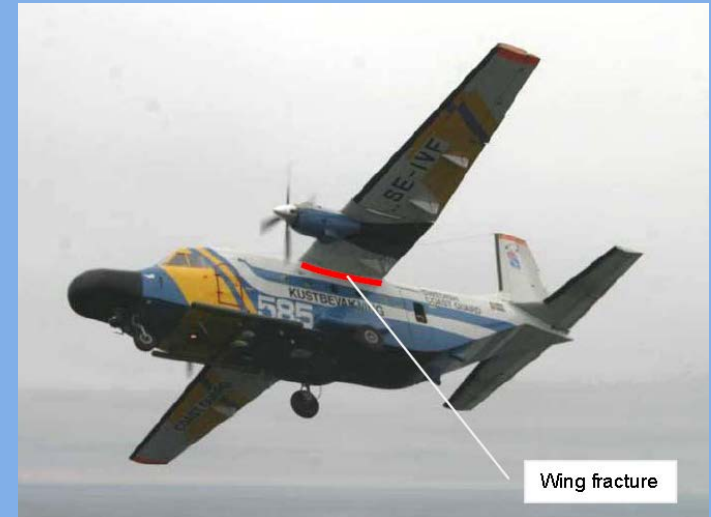
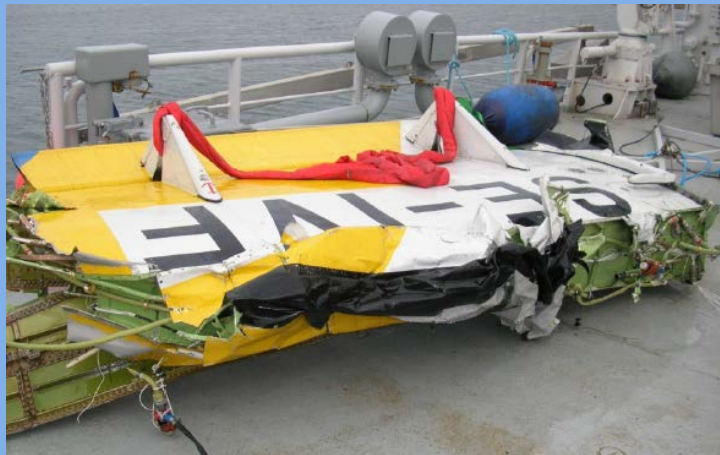
2006 SWEDISH COAST GUARD CASA 212 SE-IVF

- On 26 October 2006, a Swedish Coast Guard aircraft with call sign KBV585 crashed due to an in-flight wing failure
- The aircraft was a CASA 212 also registered as SE-IVF and under the EASA jurisdiction.

- The accident investigation had several findings:
 - *The strength of the left wing was considerably reduced as the result of an extensive fatigue crack*
 - *The crack was characteristic of Multiple Side Damage (MSD) which had developed over a long period of time.*
 - *There were signs that the accident aircraft had been operated with an unfavorable load spectrum.*
 - *No inspection threshold reduction for SID due to special mission utilization*
 - *Manufacturing defects in the wing were found.*
 - *The wing to fuselage fairings transferred wing loads to the skin due to improper installation*
 - *It would have been possible to detect the cracks visually with suitable instructions had they been performed.*

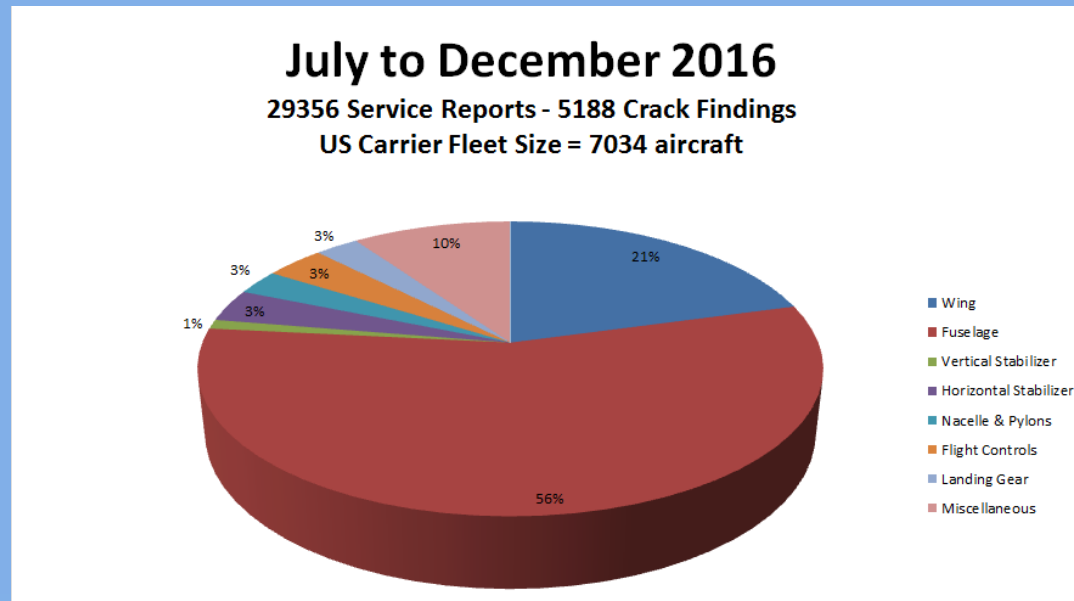
- For comparison, the FAA SDR database was queried and a sample of fatigue related services issues was obtained for an equivalent six month period from 2016.
- Over time, the number of service issues related to fatigue seem to have increased. This could be in part due to the fleet size but also due to increasing safety related inspections.

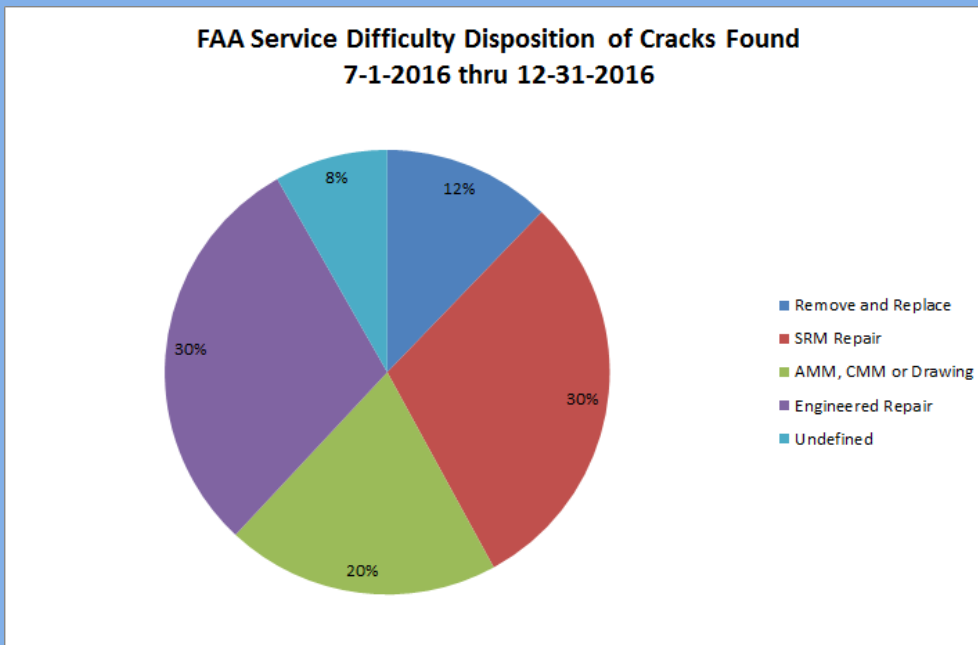
- The industry trend is positive. Fatal accidents have been reduced and in-service inspections are finding cracks prior to creating a safety issue.
- Increased inspections has resulted in increased findings which require disposition and can have impact to fleet.

- Over 60% of all findings are being handled thru the use of OEM data and result in expedited dispositions.
- Approximately 30% of findings however require specialized engineering disposition and can result in delays and sometimes in AOG conditions.
